# GLTPS

## GREEN LINE TRAIN PROTECTION SYSTEM

A CAPITAL TRANSFORMATION PROJECT

### February 2023 Review and Lookahead

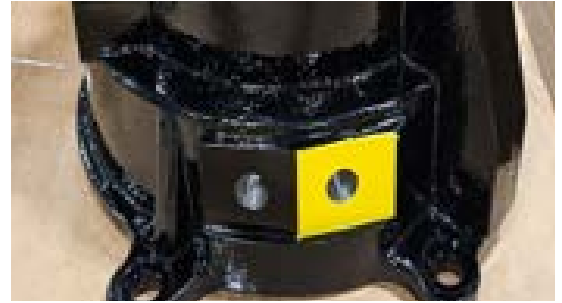
- **Both the Type 7 & 8 vehicles require speed sensor mounting redesigns** to accommodate the 2<sup>nd</sup> speed sensor for full GLTPS functionality. The Type 8 brackets will be based off the existing design and have the 2<sup>nd</sup> sensor mounting surface cantilevered to the left of center as the first iteration had interference issues with the vehicle underframe.
- **The Type 7 speed sensor housings can be reworked to accept the 2<sup>nd</sup> sensor.** 40 new housings were purchased and recently received to create a “float” of materials which allow the legacy housings to be removed and sent for modification. The yellow area indicates a newly machined flat surface which is then tapped to a unique thread pitch for the 2<sup>nd</sup> sensor.

*40 newly manufactured speed sensor housings received*

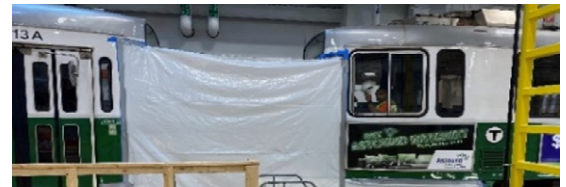
- **Abatement of the 3600 series vehicles has continued** with 46 of 86 vehicles completed, which is 54% of the affected fleet. This is a mitigation strategy to reduce the installation timeline once kits are available. Per the current schedule, abatement will conclude in June.

*Abatement area quarantined between two vehicles*

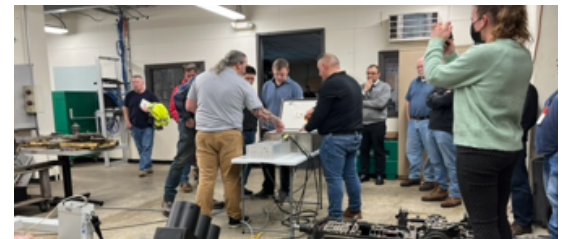
- **A wayside equipment demonstration was held at the Cabot Signaling Training Center** on February 23<sup>rd</sup>. Attendees included the Project Team, multiple Stakeholders, FTA, DPU, and System Integrator representatives. A system overview was given including electrical schematics & mechanical drawings then an equipment demonstration was completed to show how a signal, junction box, and balise work together in providing train protection

*Junction box design review with stakeholders*
