Urine Detection in Elevators: Pilot Report

Massachusetts Bay Transit Authority (MBTA), May 2023

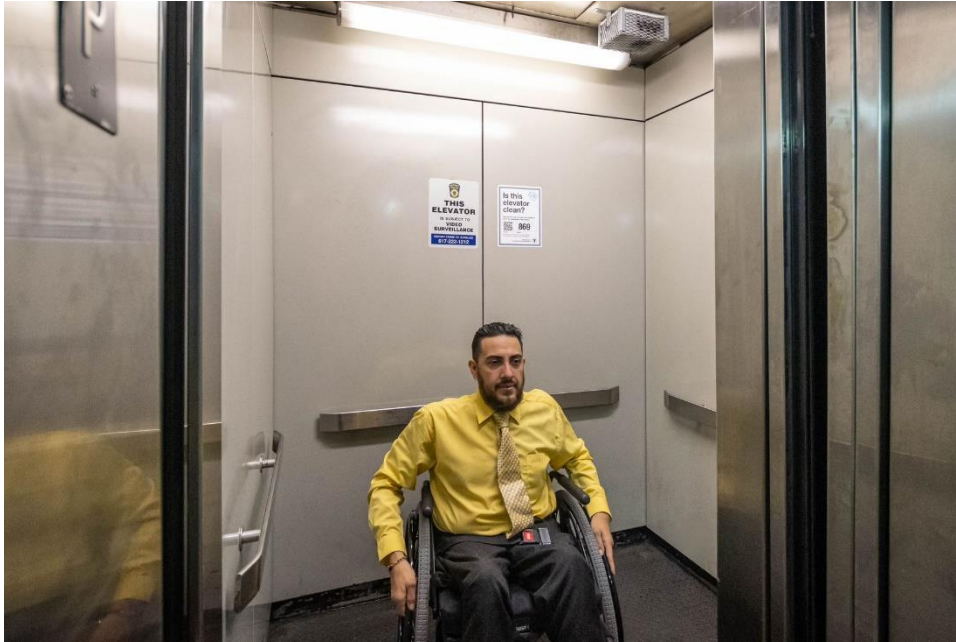
A rider who uses a wheelchair mobility device in an MBTA elevator with a urine detection sensor on the ceiling (top right).

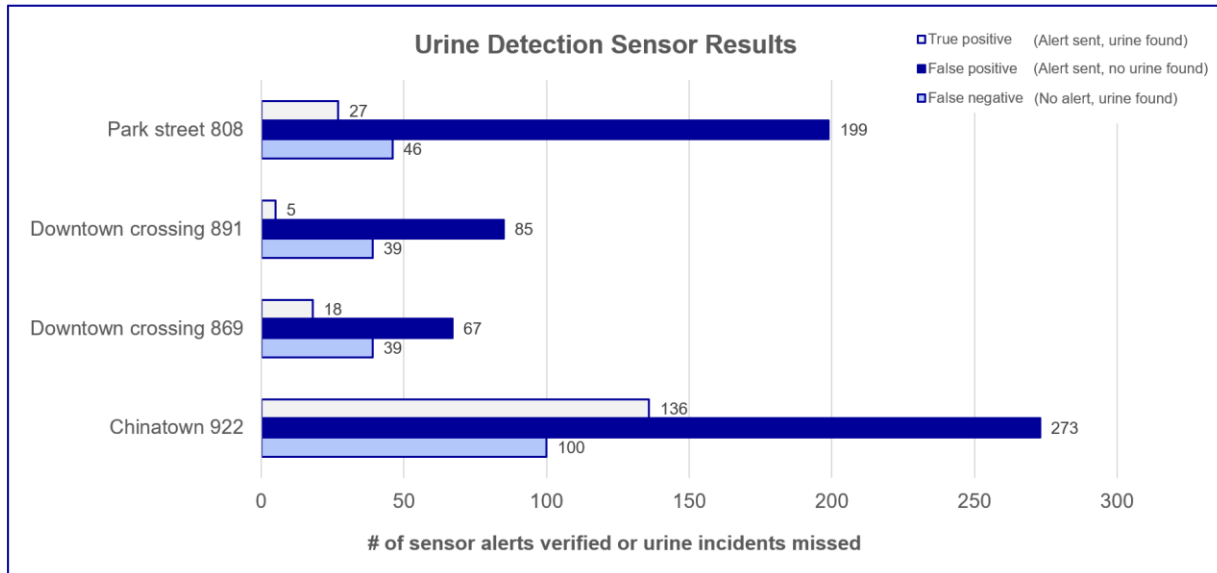
1. The sensor did not reliably detect urine. The sensors' error rate varied dramatically across elevators and time.

Pilot elevator	True positive rate (TP / # urine incidents)	False positive rate (FP / # urine incidents)	False negative rate (FN / # urine incidents)
Park street 808	37%	273%	63%
Downtown crossing 891	11%	193%	89%
Downtown crossing 869	32%	117%	68%
Chinatown 922	58%	116%	42%

The first and primary objective of the pilot was to determine how reliably the sensor detects urine. We found that the sensor did not reliably detect urine. Over the course of the pilot, the vendor pushed eight software updates to the sensors to try and improve the logic and thresholds within them, to improve accuracy. But these updates did not reliably improve, or even stabilize, accuracy. Both the false positive and false negative error rates varied significantly across elevators and time.

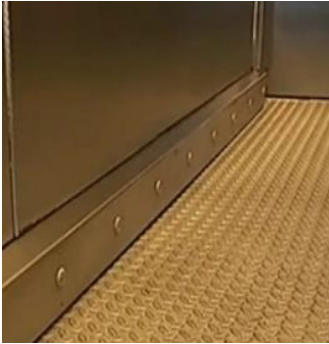
Metropolitan Atlanta Rapid Transit Authority (MARTA) was the first transit agency in the US to [pilot a urine detection device \(UDD\)](#) in an elevator for one month in 2013. The UDD (20 sensors) was installed around the base of the elevator and worked by:

- Sensing a liquid splash
- Flashing a strobe light and sounding an alarm
- Alerting MARTA police

By 2017, UDDs had been installed in [13 elevators](#) at a cost of \$10,000 per elevator. But the program has since run into issues: the cost, complexity, and maintenance burden of the electrical work required to support the UDDs has become too onerous, and occasionally affected elevator uptime.

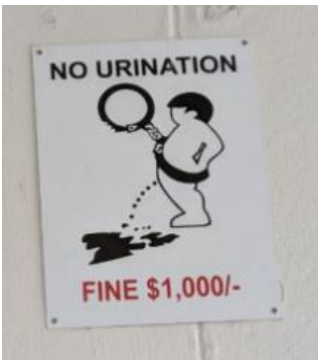
Singapore invented the first urine detection device (UDD) used in public elevators and [Parliament implemented them in the nineties](#). When the UDD detected urine it would lock the person in the elevator while a camera recorded them. The police were notified and would charge the person with a fine. Singapore's Housing and Development Board (HDB) agency has since installed CCTV cameras in lifts and phased out UDDs entirely.

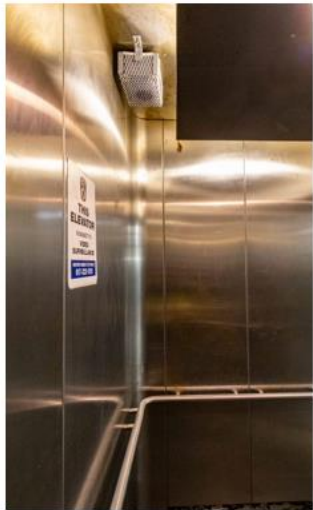
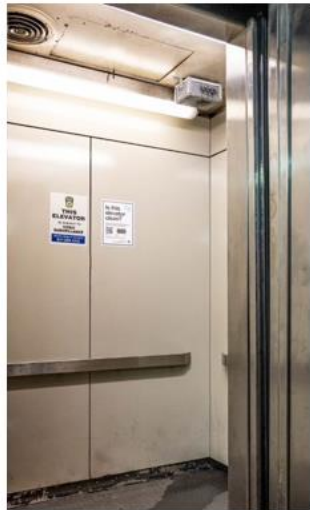
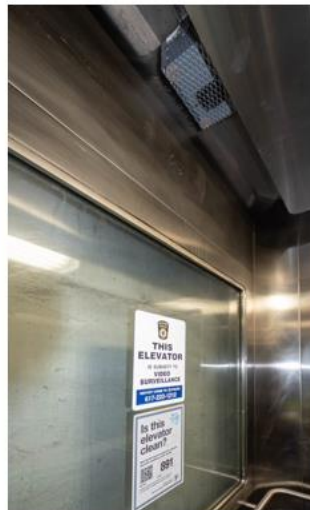
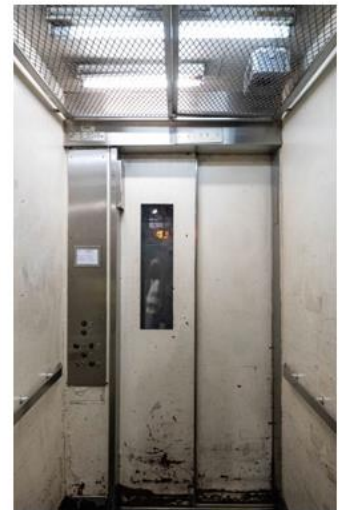
Chinatown
922

Downtown Crossing
869

Downtown Crossing
891

Park Street
808

A urine detection sensor mounted to the ceiling of the pilot elevator in Chinatown 922, Downtown Crossing 869, Downtown Crossing 891, and Park Street 808.

Vertical Transportation worked with our elevator vendor to install the sensors in the four pilot elevators. The vendor noted the ideal location for the sensor would be near the exhaust fan, which could aid in pulling in air towards the sensor. This wasn't feasible for all of the pilot elevators due to constraints like drop ceilings and electrical wiring. Each installation took less than half a day, with the exception of one sensor that took a week because of an especially thick, steel cab ceiling. After each installation, we shared photos with the vendor to confirm that the sensor had been mounted correctly.

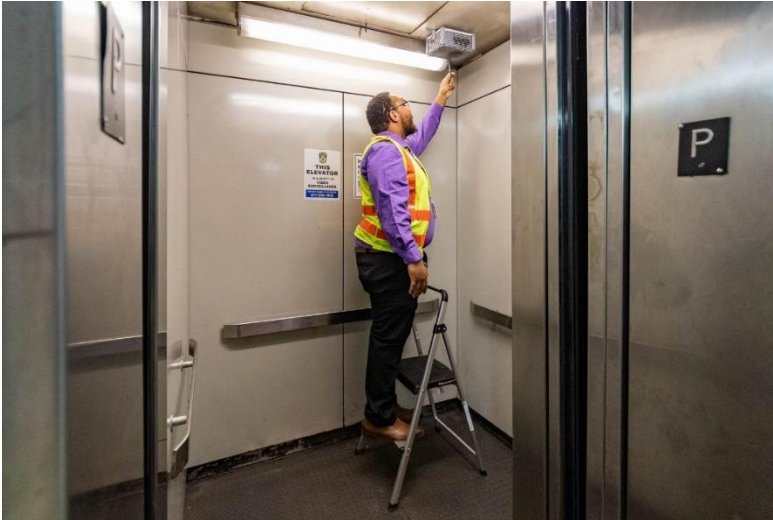
A Transit Ambassador Manager standing on a step stool in an elevator to hard reset a urine detection sensor

The sensors remained online in the first month of the pilot. In the second, though, we began to see issues with them going offline. The table below summarizes those incidents, and the resulting uptime of each sensor. The vendor managed to bring three sensors back online with a remote reboot but the sensor in Chinatown 922 needed to be reset locally, by a Transit Ambassador Manager-on-Duty, seven times. The vendor attributed this series of incidents to “server issues” and couldn’t tell us more.

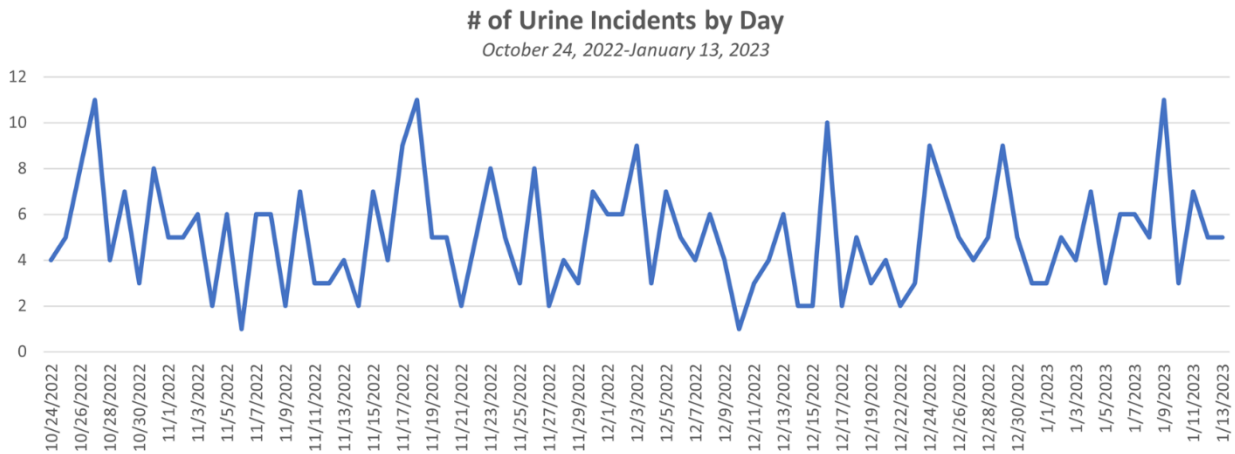
In 12 weeks, there were 410 separate instances of people urinating in the four pilot elevators. Chinatown 922 accounted for more than half of all of these incidents.

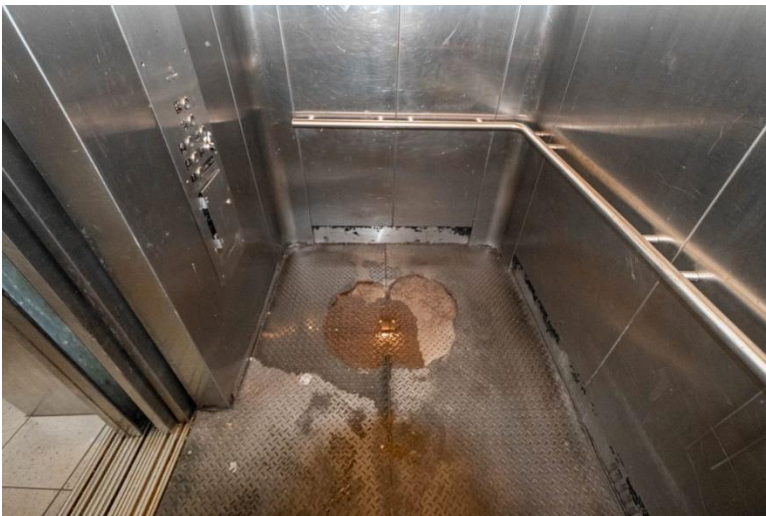
Urine in Chinatown elevator 922

Chinatown 922 was, initially, the location with the best-performing sensor. We attributed this to the fact that the sensor had the most training data (i.e., the most urine incidents), and that its mounting conditions were optimal (small elevator, low ceiling, sensor next to the exhaust fan).
